KANSAS DEPARTMENT OF HEALTH AND ENVIRONMI
Division of Environment
Waste Management Program

COMPLIANCE INSPECTION CHECKLIST HAZARDOUS WASTE COVER PAGE

HAZARDOUS WASTE T/S/D FACILITY COMPLIANCE INSPECTION CHECKLIST

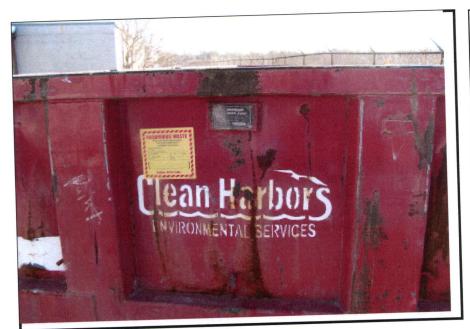
Photo No.:	1
Archive Disc File No.:	FY10
Date: J	anuary 27, 2010
Time:	10:49 a.m.
	de west side of Building B
Direction Faced:	East
Weather Conditions:	Sunny
Comments:

During the perimeter inspection I observed eleven 20-cubic-yard (yd³) roll-off containers located on the west side of Building B in the trailer parking area. Ten of the roll-off containers were empty. Mr. Noble stated empty roll-off containers were temporarily stored onsite before they are returned to customers. I observed one 20-yd³ roll-off container was open and labeled with a hazardous waste label (photo 1). The roll-off container contained approximately three percent of a dark colored solid on the sides and bottom of the container. Mr. Noble stated the container was mislabeled and previously contained oily soil and debris from a spill cleanup. Mr. Noble provided me with the waste material profile for the waste that was in the container (Attachment 2). A

A 20 cubic-yard roll-off container labeled hazardous waste. Mr. Noble stated the container was mislabeled and did not contain hazardous waste but rather the container had contained non-hazardous oily soil and debris.

comment was provided to the facility as Comment B on the NONC to label the roll-off containers correctly and to remove all prior hazardous waste labels from containers if the container did not contain hazardous waste.

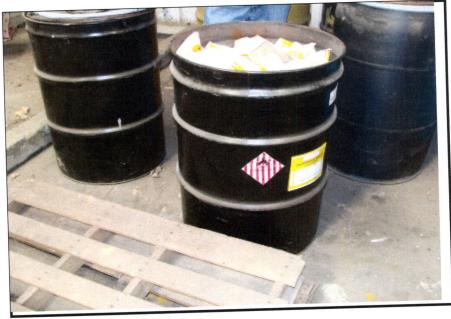
Photo No.:	2
Archive Disc File No.:	FY10
	anuary 27, 2010
Time:	11:21 a.m.
Location:	Building C
Direction Faced:	North
Weather Conditions:	Sunny
Comments:	hazardous waste storage

stored onsite for 593 days. The storage container was full of hazardous waste personal protective equipment (PPE), stickers, and paper backing for stickers (photo 2 and 4).

A black metal 55-gallon hazardous waste storage container. Mr. Noble opened the container. The container is full of hazardous waste personal protective equipment (PPE), stickers, and paper backing for stickers. The two black 55-gallon containers depicted behind the labeled container were empty.

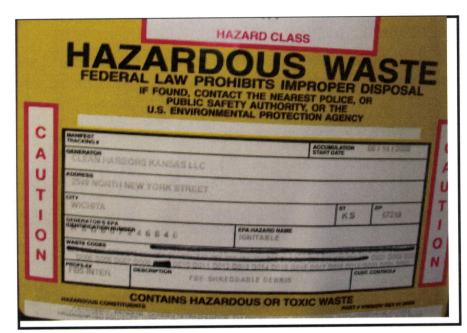
<u>Violation 1</u>. **Storage of hazardous waste for more than one year in violation of K.A.R. 28-31-14/40 CFR 268.50(b).** Located in Building C in the northwest portion of Containment Management Unit (CMU) C700, I observed one black metal 55-gallon storage container labeled hazardous waste (photo 2). The storage container was located in an area where empty containers such as metal 55-gallon containers, 30-gallon fiberboard containers, and plastic 65-gallon over-pack containers that would be distributed to customers were being stored. The storage container was marked with an accumulation start date of June 14, 2008 (photo 3). The storage container had been

Failure to comply with the permit for containers of onsite generated waste stored over 90 days in violation of Permit Section III. A. / 40 CFR 262 was originally cited on the NONC. A letter was mailed to Clean Harbors Kansas, L.L.C. on February 8, 2010, changing the citation (Attachment 3).

Violation 1: 40 CFR 268.50(b). Storage of hazardous waste over one year.

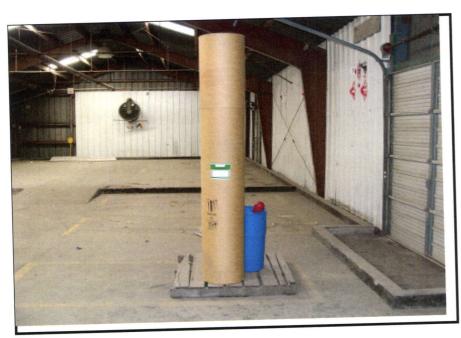
Photo No.:	5
Archive Disc File No.:	FY10
Date:	January 27, 2010
Time:	11:14 a.m.
Location:	Building C
Direction Faced:	West
Weather Conditions:	Sunny
Comments:	
	and the Indiana The

- a) Located in Building C, CMU C400, I observed one closed and labeled fiberboard container accumulating spent 8-foot fluorescent lamps (photo 5). The label on the container read "Non-Hazardous Waste," and the accumulation start date was marked as July 21, 2008 (photo 6). The container contained twelve spent silver tipped GE 8-foot fluorescent lamps. Mr. Noble provided me the material safety data sheet (MSDS) he had on file as the document for his waste determination (Attachment 4). I observed the MSDS provided no evidence that the fluorescent lamps were non-hazardous. Mr. Noble stated the facility hadn't ever determined if their fluorescent lamps were hazardous. He stated he thought universal wastes were non-hazardous.

A closed and labeled fiberboard container. The container contained 12 spent silver tipped GE 8-foot fluorescent lamps. The blue container depicted behind the fiberboard container contained facility equipment.

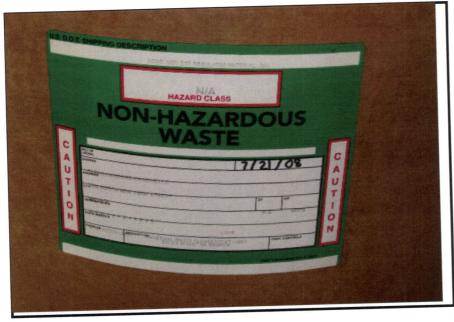
Photo No.:	6	
Archive Disc File No.:	FY10	
Date:	January 27, 2010	
Time:	11:14 a.m.	
Location:	Building C	
Direction Faced:	West	
Weather Conditions:	Sunny	
Comments:		
Close-up of the container label depicted in photo 5.

Close-up of the container label depicted in photo 5. The accumulation start date written on the container reads 7/21/08.

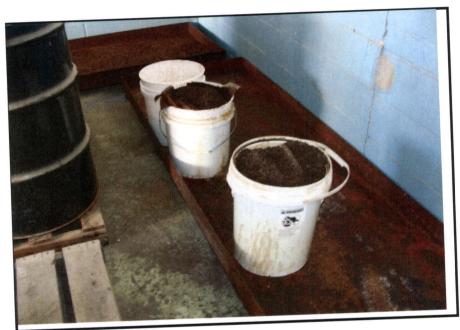
Photo No.:	7
Archive Disc File No.:	FY10
Date:	January 27, 2010
Time:	11:48 a.m.
Location:	Building D
Direction Faced:	South
Weather Conditions:	Sunny
Comments:

- b) Located in the east storage area adjacent to the west side of the industrial elevator shaft in Building D, I observed the following three open and unlabeled white 5-gallon containers (photo 7):

Three open and unlabeled 5-gallon containers. The container in the back (south) is approximately one-third full of an unknown dark brown solid. The container in the middle is full of a dark brown solid and additionally contained a dark brown cardboard. The container in front (north) is full and contains an unknown dark brown solid. The black 55-gallon container depicted on the left contained product.

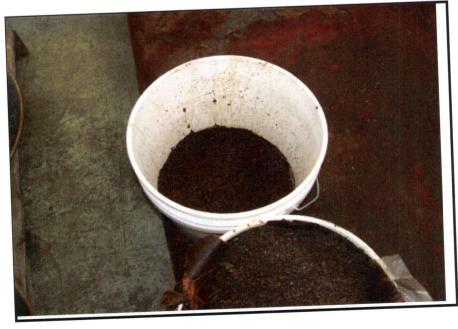
Photo No.:	8
Archive Disc File No.:	FY10
Date:	January 27, 2010
Time:	11:48 a.m.
Location:	Building D
Direction Faced:	South
Weather Conditions:	Sunny
Comments: Close-up of the conte	ents of the back (south) container depicted in photo 7.

- 1) The south 5-gallon container was approximately one-third full of a dark brown colored solid. The interior side walls of the container had been stained by a dark liquid (photo 8). Mr. Noble did not know what was in the container.
